# CASE REPORT. FEMORAL VEIN CATHETER LEADS TO SEPTIC SHOCK AND DEATH: COULD ECOGRAPHY BE USEFUL TO PREVENT MISPLACEMENT?

Argomento: Caso clinico

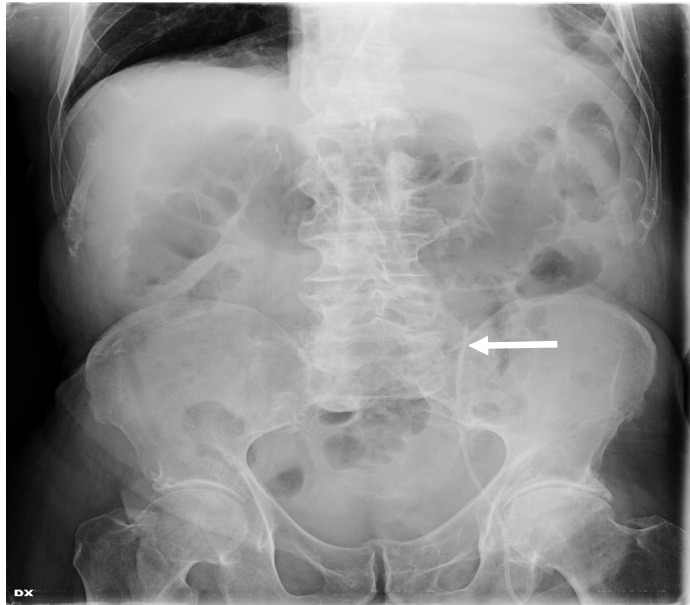
Fig 1. Plain abdominal film: left femoral CVC (white arrows) with left course to xifopubic axis. This is a not common position. CVC may mispositioned in iliolumbar vein or in an anatomic variants such as a left common iliac vein ascendent to renal vein or a left inferior vena cava or an inferior vena cava transposed.

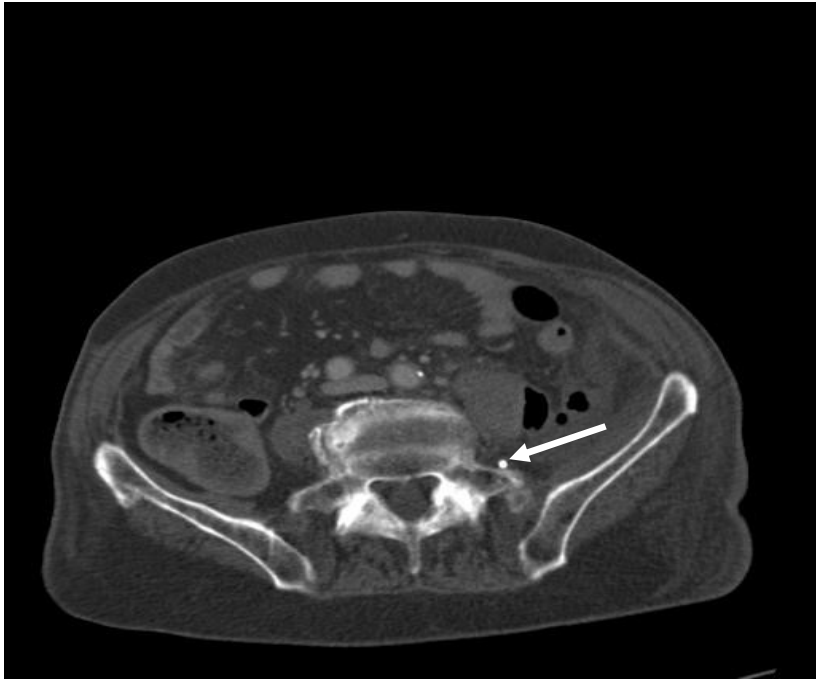
Fig 2. Contrast CT: axial images with non anatomical variants of IVC, aorta or left iliac vein. The tip of CVC is close to left transverse process of a lumbar vertebra, in left iliolumbar vein

In the twentieth day, the patient presented hyperpyrexia and acute abdomen. Contrast computed tomography demonstrated the CVC in the left iliolumbar vein with retroperitoneal phlegmon. The patient was then transferred to operating room to perform exploratory laparotomy and evacuative toilette. Postoperatively admitted to ICU, the patient developed unresponsive septic shock and died after seven days.

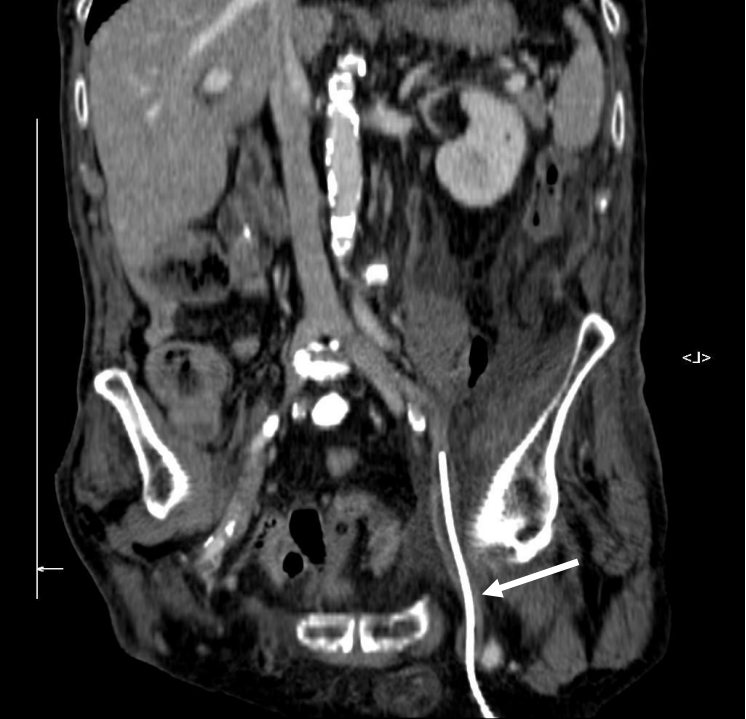
Fig.3 Coronal MPR images with venous axis: CVC in external left iliac vein, not in common left iliac vein or IVC (tip of CVC is not visualized); non anatomical venous variants.

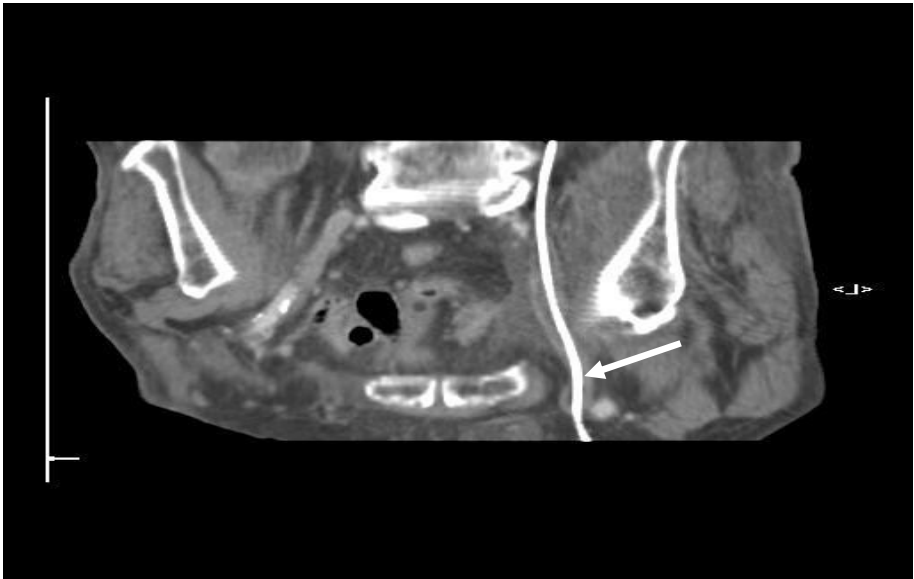
Fig.4 Coronal MPR images with entire course of CVC: proximal catheter is inside left external iliac vein, distal part of catheter is not in common left iliac vein, but run back, close to transverse process of a lumbar vertebra, in left iliolumbar vein.
